Case History

Hydro Power: treating the source of a problem, not just a symptom

*By S. A. Hurricks and B. A. Urquhart,
Condition Monitoring Engineers
Northern Thermal Group
Electricorp Production
New Zealand*

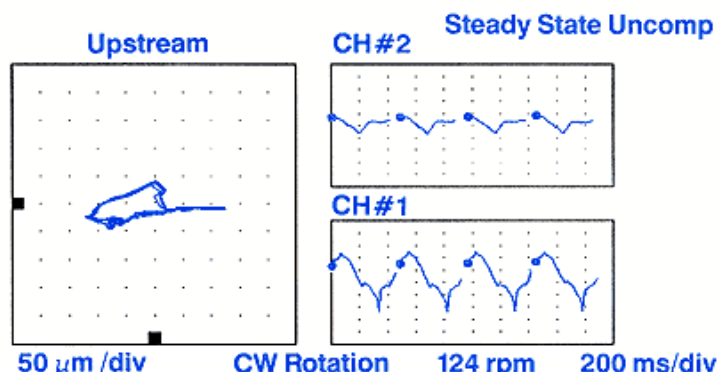
Figure 2
Orbit/Timebase plot of main guide bearing

After the machine was shut down, the data was downloaded to a portable computer so that the shaft Orbit pattern could be analyzed with the ADRE® 3 Software. It was evident from observing the shaft Orbit (Figure 2) that shaft contact had occurred.

The upper guide bearing on these machines is only a relatively small, steady bearing. The initial question was "Why couldn't the bearing pad be reinstalled after repair?" Obviously, the shaft had moved over while the bearing pad was removed for repair. Since this happened while the machine was stationary, it indicated that this problem was not purely dynamic.

The next question to be answered was, "Why didn't the main guide bearing restrict the shaft movement, preventing contact?" One possible hypothesis, as frightening as it might have been since the generator rotor alone weighs 100 tons, was that the whole main guide bearing assembly was not securely anchored to its foundation!

When Waipapa's maintenance personnel inspected the main guide bearing assembly, they discovered that it had worked itself loose. The large dowel pins, which locate the bearing carrier assembly, had worked themselves out, allowing the bearing assembly to move.

Consequently, the shaft radial load was transferred to the small upper guide bearing. As a result, the upper guide bearing was overloaded, causing the contact and high temperatures. The main guide bearing assembly was realigned and tightened. The machine has run with no further problems since then.
